St. Joseph's Parish
Structural Assessment Rock Foundation at Old Mission San Jose
43300 Mission Boulevard, Fremont, CA

This report summarizes the results of our preliminary investigation and assessment of the West wall foundation at the Old Mission San Jose site located on Mission Boulevard in Fremont, CA.

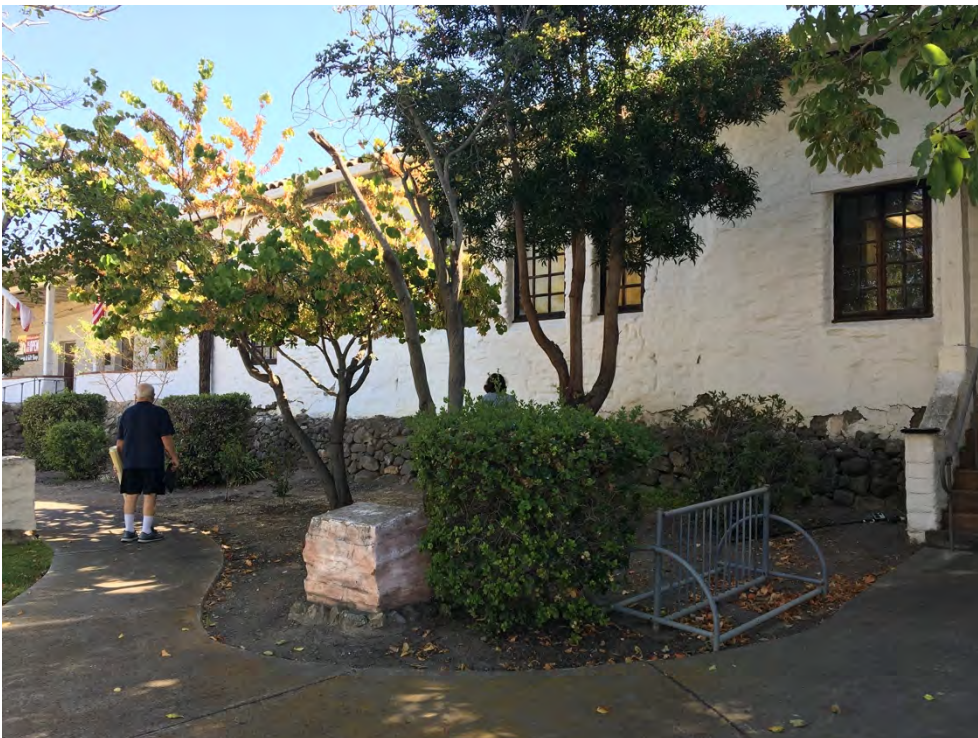
West wall looking NE

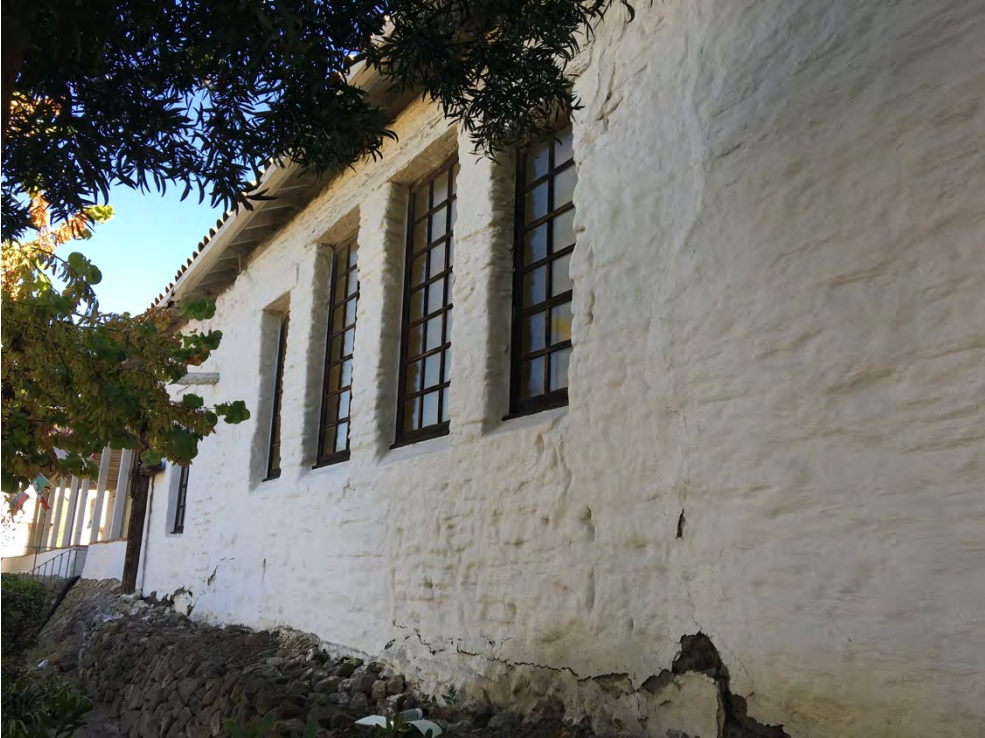
Closer view of West wall

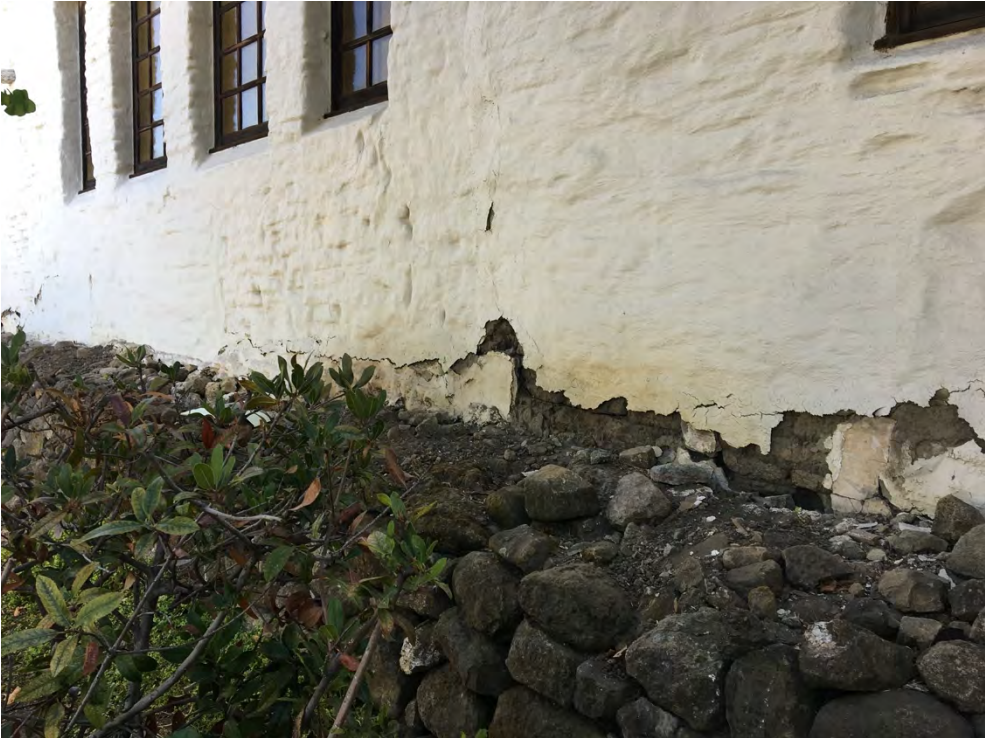
Detailed view of rock / adobe wall interface

The test pits revealed that the rock retaining walls are located approximately 3 feet in front of the existing adobe brick walls and do not extend below the main building adobe walls. As such, erosion due to water damage and ground squirrel activity are leading to degradation of the soil between the rock wall and the adobe brick and to an unknown extent below the adobe wall.

Accounting for the low compressive strength of the adobe material (approximately 300 psi per the AME report) we do not believe that any form of excavation below the adobe wall should be performed as this could lead to further damage to the walls. It is therefore recommended that the existing rock wall be temporarily removed, the soil below the adobe wall be jet grouted to a depth of at least 8 feet below the adobe wall and at least 2 feet laterally from the face of the adobe wall, a permanent concrete retaining wall be built immediately adjacent to the adobe wall and jet grouted subgrade, and that the rock retaining wall be reconstructed to conceal the concrete wall. Since the new rock wall will no longer act as a true retaining wall, it can be rebuilt as loose material, or if desired it can be rebuilt by grouting the rocks to more closely match the grouted rock wall immediately north of the wall to be replaced.
